ALNWICK CIVIC SOCIETY

SURVEY OF LANES

December 1995

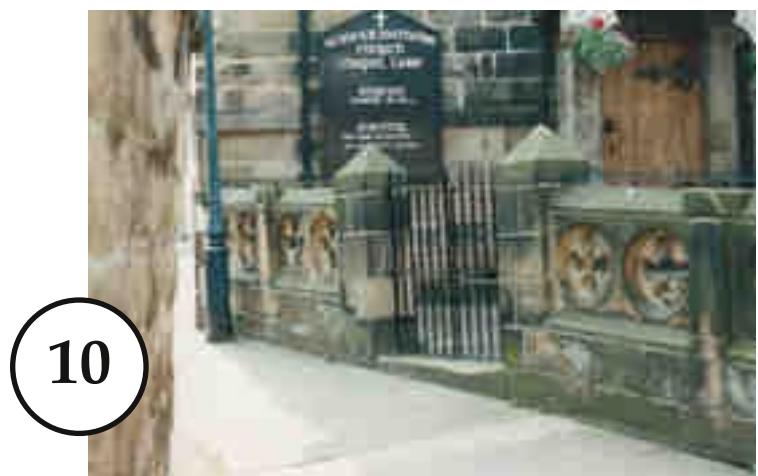
10

From the bollard northwards the paving is of rough, in situ concrete, patched where services have been repaired; there is no sidewalk and drainage is by two shallow channels formed in the concrete (photos 10, 11, 12, 14, 15 and 16).

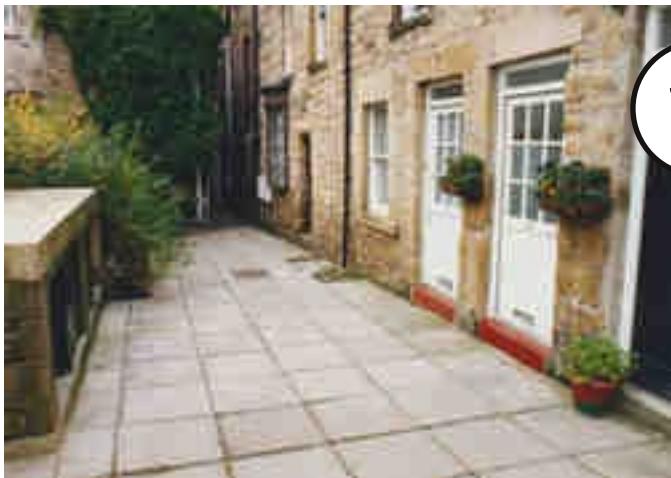
11

Both Upper (photo 10) and Lower (photo 11) Dodd's Lane are paved with concrete flags, relieved in parts of the upper section with block paviours to create a contrasting feature, enhanced by rustic timber benches.

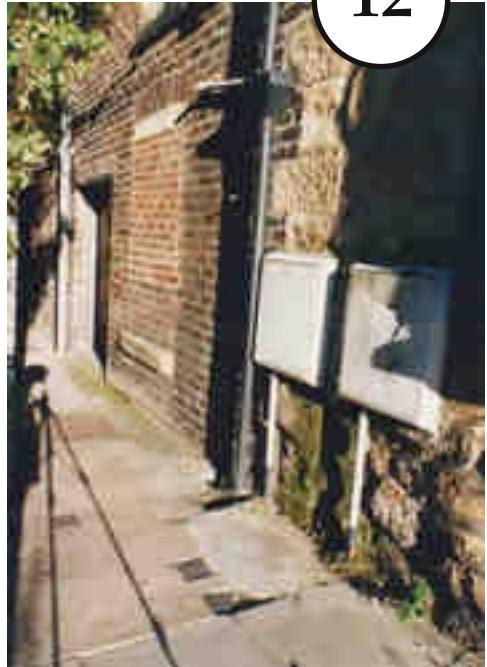
12

The floor of the covered alleyway at the Market Street end, and of the areas beside the adjoining houses, is degraded by the presence of elderly in-situ concrete in poor condition (photo 12).

- replacement of street lighting fittings with better quality ones
- improvements to the flooring and lighting in the passageway at Market Street
- removal of the patches of render on the wall of 22 Green Batt, and restoration of the stonework beneath it
- removal of the TV satellite dish and its supporting bracket on 22 Green Batt

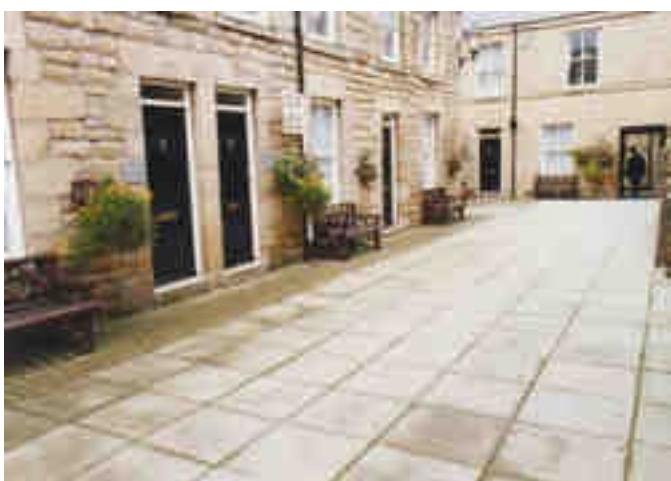
15

In Upper Dodd's Lane, the west side, period dwellings have modern sash windows which are already suffering from wet-rot and will need repair or replacement before long (photo 15). The modern houses on the west side have good-quality, double-glazed, softwood sash windows.

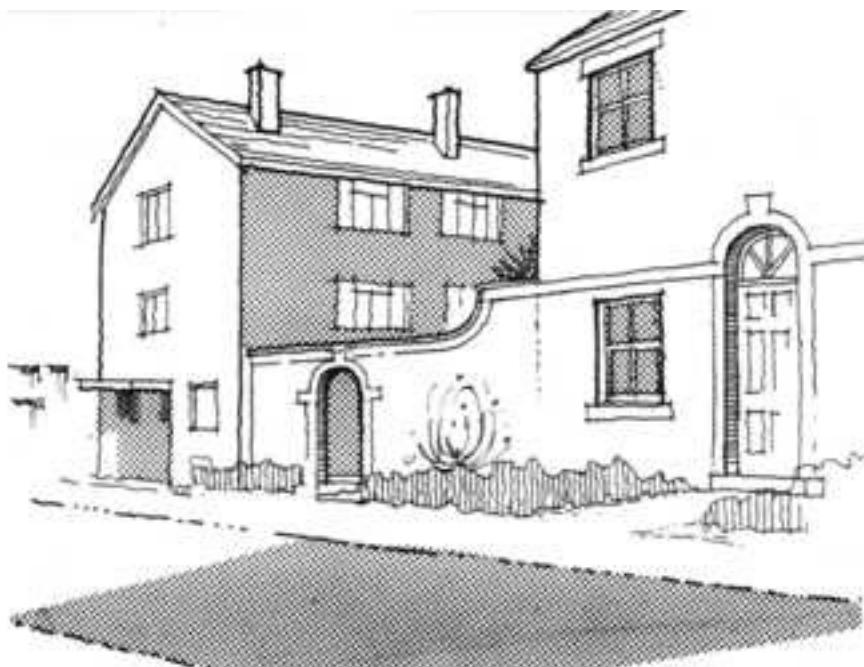
Photo 10: accepting that the new housing and tree planting on the east side of the lane replacing the Northumberland Gazette building is disappointingly trite in design, and that St Michael's Square is of typical post-War urban housing estate design, there is not much that can be done to the buildings to restore the original character of the lane. A high wall with an arched pedestrian entrance is suggested, as illustrated in the sketch below.

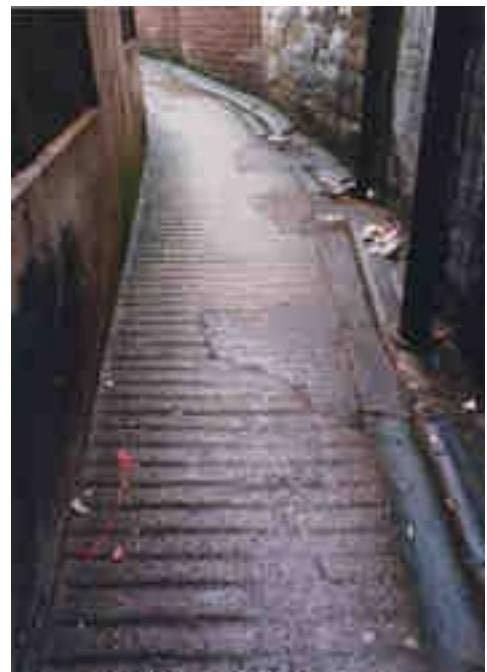
4

On the east side within the passage there are three large windows covered with a rusty security iron mesh (photo 4), and beyond is a door leading into the Restaurant. On the west side, a door in the passage leads up stairs to the dental surgery and flat.

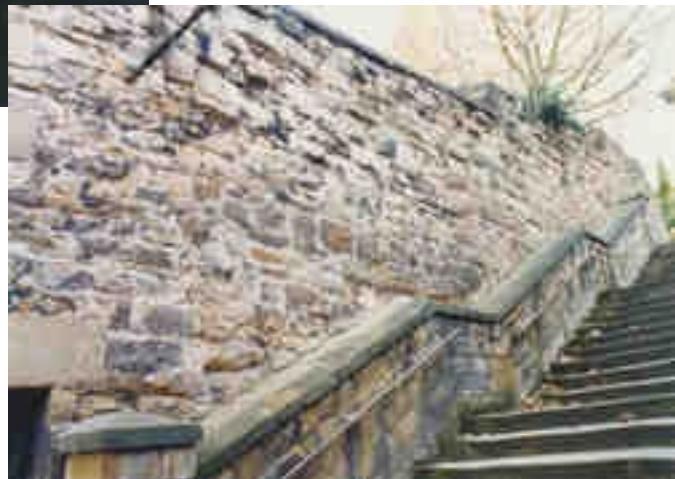
12

The rustic stone flank walls of the external stairway are badly pointed, dirty and generally neglected (photo 12). The handrails are in need of repair.

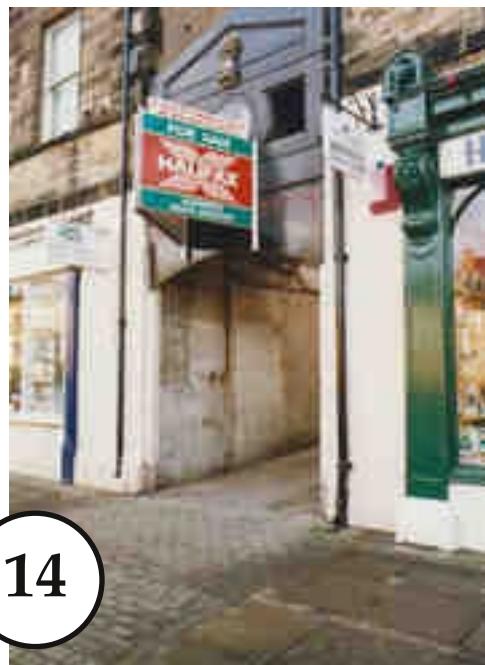
The Bondgate/Market Street entrance is marked by an interesting Clock canopy feature (photos 14 and 15). This appears to be in reasonable condition and is worthy of restoration. An arched, plywood panel advertising the Hill House Art Gallery was added to the underside of the canopy, but the lettering has been painted out. The board is no longer required and should be removed.

- all stone walls facing the yard, and all walls that relate to the original burgage plot boundaries require remedial work or treatment to meet Conservation Area standards; - generally, all blockwork, brickwork and rendered stonework should be replaced by good quality stonework;
- the overgrown wasteland in the plot to the east side of the old Corn Exchange should be restored as an attractive garden, using low-maintenance, ground-covering shrubs;
- all windows and doors facing onto the yard require renewal to Conservation Area standards;
- a design solution should be sought for the unsightly *at-roofed* extension to the rear of Ham1y's; and
- the Clock canopy should be refurbished.

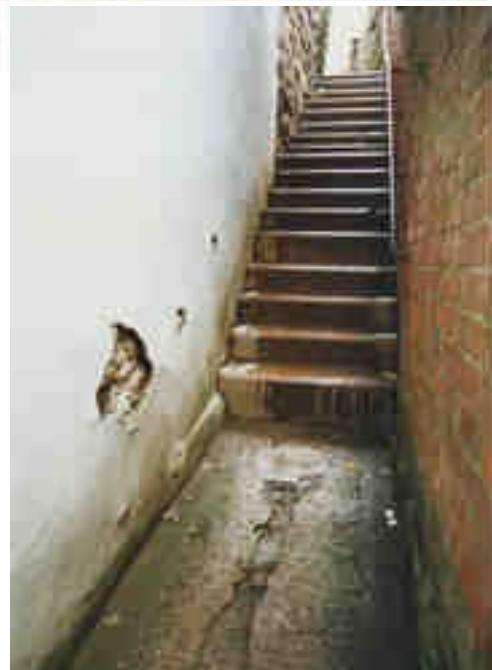
5

The lane's floor throughout this lower section is of insitu concrete, in very poor condition, and with an open surface-water drainage charmer on one side (photos 4- 7).

- the flooring should be in well-laid stone e-,gas throughout, with provision for surface drainage; because the lane is so narrow, and the high walls so intimidating, these high walls should be made as light as possible by cleaning and, where appropriate, repairing and re-painting the existing rendered surfaces; and
