ALNWICK CIVIC SOCIETY

SURVEY OF LANES

December 1995

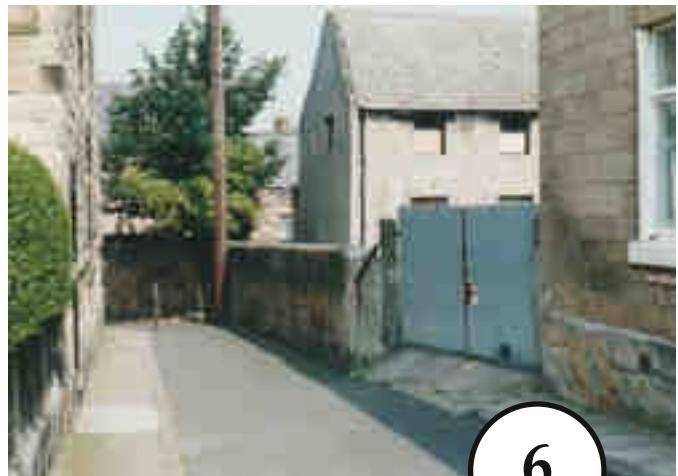
6

The lower three or four courses of the walls of No 15/ 15A have been rendered (photos 1 and 2); there are several examples of crude, cement mortar pointing of walls at low level (e.g. photos 4 and 6) and at upper levels (photos 12 and 13). The yard wall at the chicane opposite the entrance to the Church appears to have been rebuilt since the OS map was prepared; it is leaning, and has partly collapsed due to the growth of a tree (photo 7). Two garden gates opposite No 1A (and believed to belong to the owners of No 1A) are broken and permanently open, resulting in the dumping of rubbish (photos 8 and 9). The gate to the yard immediately north of No 2 consists of a metal frame clad in corrugated iron, which is completely out of character with the rest of Chapel Lane (photos 5 and 6).

- The stone paving of the Chapel Yard should be restored.
- The brickwork dwarf walls outside Nos 7-13 should be replaced with stonework.
- Householders should be encouraged to remove rendering and cement mortar pointing from the lower courses of house walls and to repoint with lime mortar.

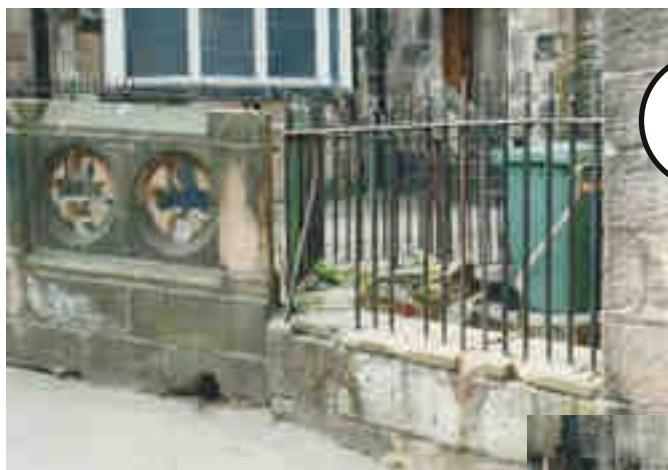
11

From the bollard northwards the paving is of rough, in situ concrete, patched where services have been repaired; there is no sidewalk and drainage is by two shallow channels formed in the concrete (photos 10, 11, 12, 14, 15 and 16).

The railings of No 1A at the Church entrance are in poor condition (photo 11).

- The corrugated iron gate should be replaced with a more appropriate style of security gate.
- The iron railings of No 1A at the Church entrance should be replaced or refurbished.

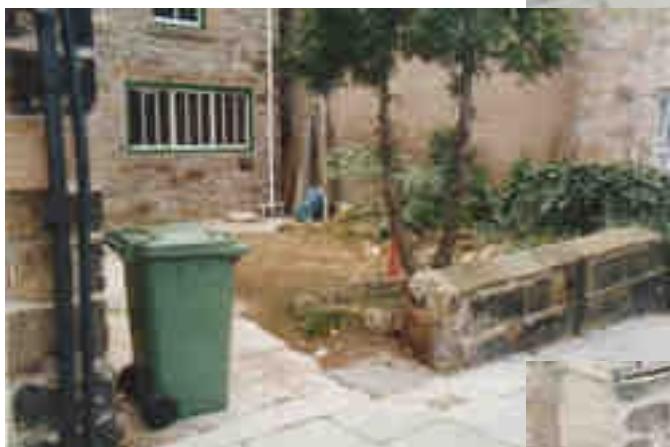
12

Photo 12: the work to restore "Laid Back" has not been complemented by the restoration of the front garden, which remains an eyesore. This should be done.

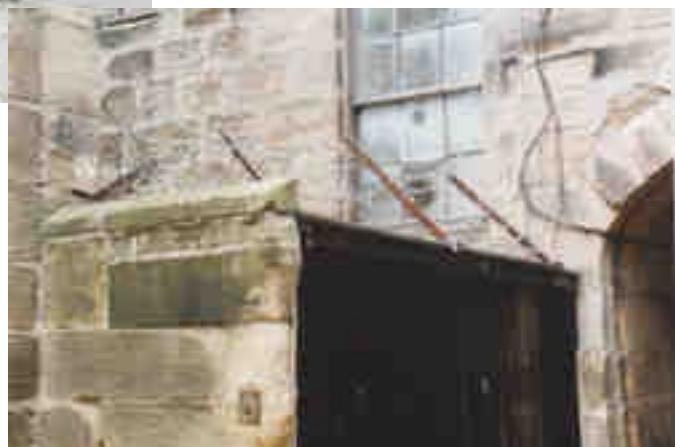
13

Photo 13: this clumsy and ineffective barbed wire construction at No 2 should be replaced by a more effective and better-looking security system.

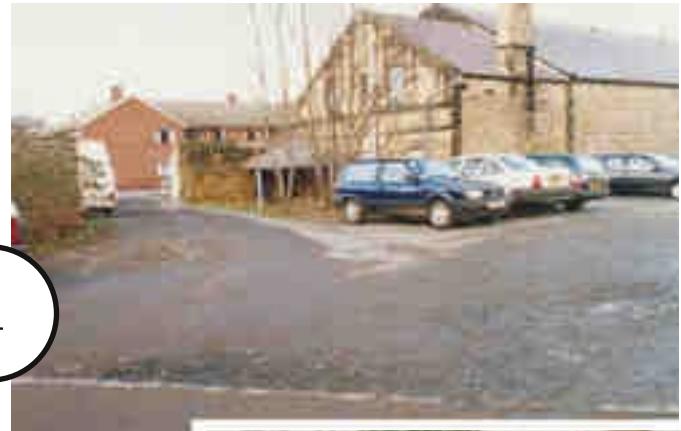
A rough pedestrian path (photo 2), about 2m wide, along the east side of the old Corn Exchange is covered with a mixture of mud and loose gravel, overgrown with grass and weeds. The open side of this path defines the eastern boundary of the burgage plot, in the form of a dilapidated, low brick wall which acts as a retaining wall of varying height to the roughly-surfaced (photo 3) Roxburgh Place Car park (which is to be surfaced and landscaped by the District Council in due course - see Figure 6.4).

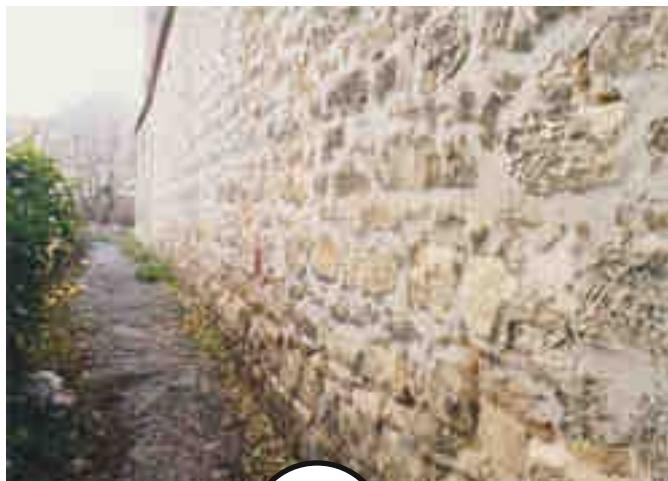
The east (photo 8) and west (photo 9) elevations of the old Corn Exchange are of random rubble stonework which is in a poor state of repair due to bad pointing and structural movement, with some serious cracking, particularly in the west wall. The good ashlar stonework of the north elevation (photo 10) and the lower quality, coursed stonework in the south elevation (photo 11) are also in a poor state. Boarded-up openings, inefficient guttering and exposed roof timbers have all added to the rapid decay of the building.

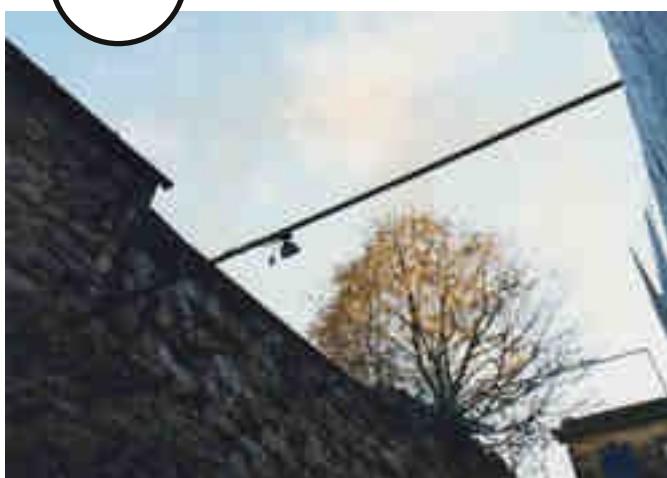
12

The rustic stone flank walls of the external stairway are badly pointed, dirty and generally neglected (photo 12). The handrails are in need of repair.
